TECHNICAL REPORT
TR-NAVFAC-EXWC-EV-1704
DECEMBER 2016

**Innovative Acoustic Sensor Technologies for Leak Detection
in Challenging Pipe Types (Cost and Performance Report)**

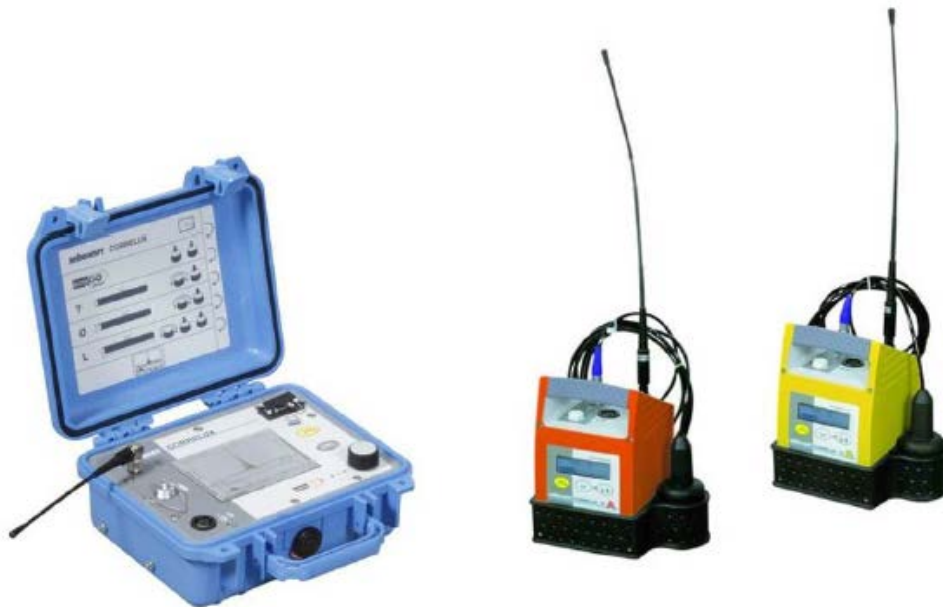
The Correlux HL6000X is a correlator system used for automatically pinpointing leaks in water pipes (see Figure 2-5). It consists of two radio transmitters that connect to piezo-ceramic accelerometers (transmitter A and B), the correlator (the user interface device), correlation software, and headphones. The correlator device can be connected to a personal computer for software updates, downloading data, and to printout results. The correlator device has enough memory to record data for up to 10 segments. It is powered by a battery with an operational life of 12 hours. Each radio transmitter is powered by an internal battery with an operational life of 15 hours. All devices can also be externally powered using a 12-volt direct current car adapter or 110-volt alternating current power supply.

Figure 2-5. Correlux HL6000X System (Courtesy of Vivax-Metrotech)

The correlator system works by placing the two accelerometers (sensors) at either end of a pipe section (on valves, exposed pipe sections, or hydrants as the local conditions dictates). Table 2-6 shows the recommended sensor spacing based upon pipe type. The sensor spacing must be accurately measured for input into the correlator if a leak is detected. No information was

available on a minimum detectable leak size or typical location accuracy of the Correlux system. The correlator is activated and the sensor outputs are transmitted to the correlator. Once the correlator unit receives the sensor outputs and inputs data into the correlation software for analysis, the user provides the pipe data including the pipe material, pipe diameter, and pipe length. The device then displays the correlation graph, which compares both signals and provides the distance to the leak. For each correlation, the software automatically sets filters depending on the pipe material, and the filter limits can be adjusted by the user. If a leak is detected, the correlator provides the leak location in feet away from each of the two sensors. At that point the operator uses a listening probe to validate the leak location at the calculated distance from the sensors. If no leak is detected in the correlator, a zero reading is displayed and one of the sensors can be placed to evaluate the next pipe segment in the field survey.

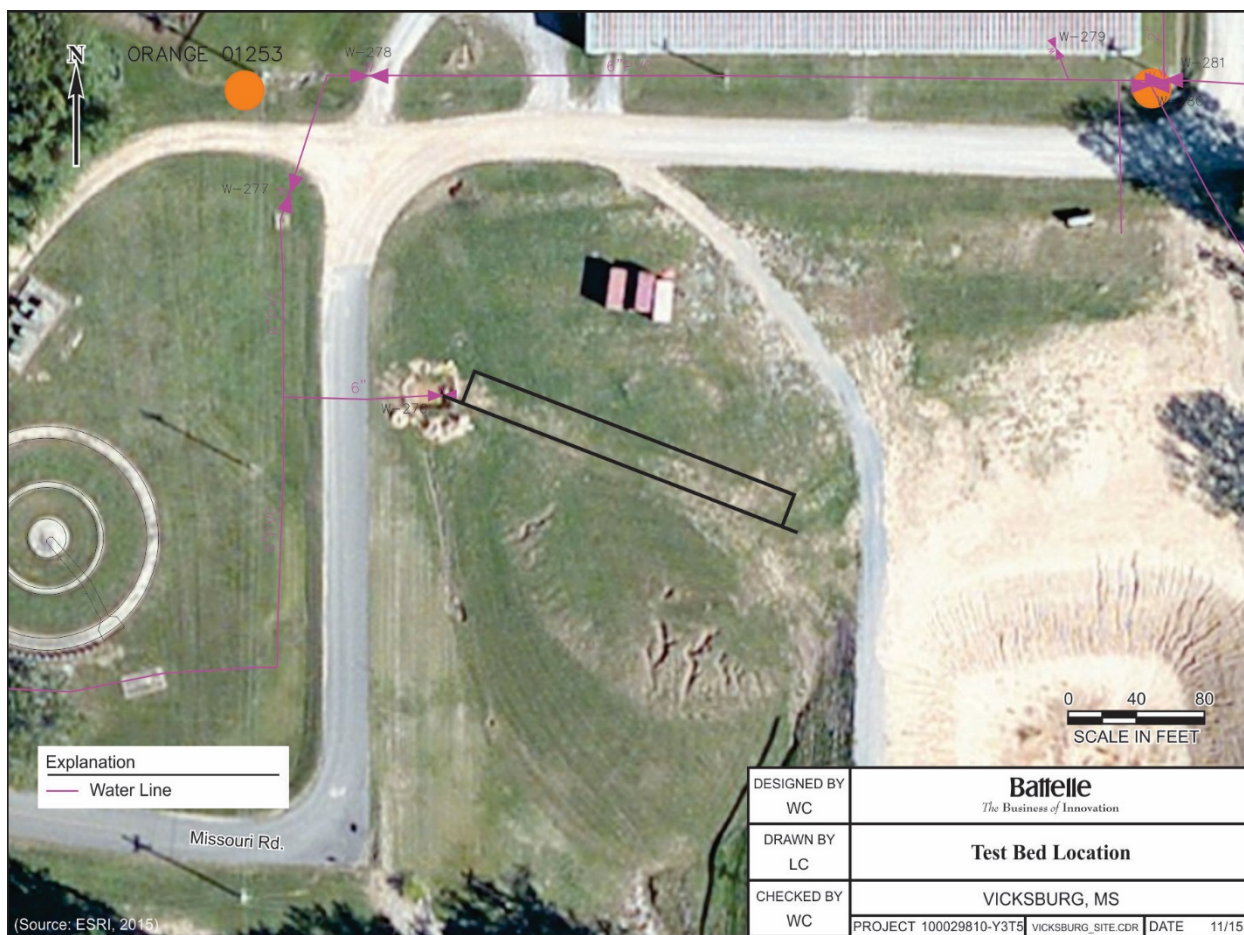
A 200-foot test bed was constructed for use in the project, which was located in the northeastern corner of the ERDC campus (see Figure 4-2). It was previously used as part of a hydraulic testing facility with a 6-inch PVC water supply line leading to a large surface impoundment. The test bed consisted of 90 feet of 6-inch DI pipe and 110 feet of 6-inch PVC pipe. Risers were installed on the test sections to allow for the placement of the acoustic sensors including accelerometers and hydrophones. After test bed construction, 10 simulated leak locations were installed on the main line, along with one simulated leak on a nearby PVC lateral line. The 11 total simulated leaks were established using corporation valves and orifice plates with openings of various diameters (as discussed in Section 5.0).

Figure 4-2. Test Bed Site Location

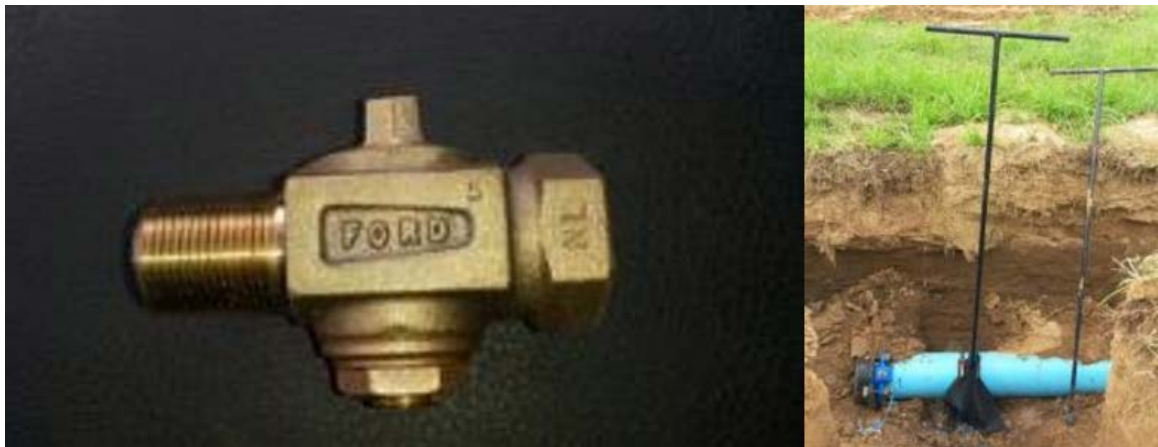
Figure 5-2. Simulated Leak Configuration Using Corporation Valves

- **Independent variables:** The independent variables for the controlled test bed included the simulated leak flow rate and the simulated leak location. The simulated leak flow rate was varied through the use of orifice plates of varying sizes installed in the test bed. Several leak locations were installed in the test bed to assess the accuracy of the cross-correlation methods in pinpointing the leak locations.
